BETHANY CITY RESERVOIR

HARRISON COUNTY, MISSOURI

MO 10051

PHASE 1 INSPECTION REPORT NATIONAL DAM SAFETY PROGRAM

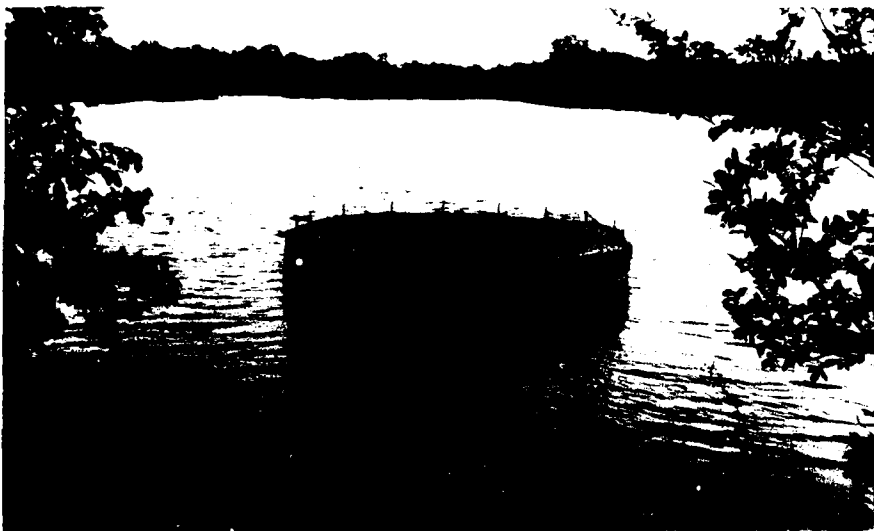
A notation of elevation 130 is also shown on Sheet 4 on the elevation view of the spillway (see Appendix C). It is the opinion of the inspection team that this is the as-built elevation of the spillway instead of the 128 as originally designed. At some later date, the crest of the spillway was raised another two feet ± by the addition of a vertical sided concrete cap which covers the original lip of the spillway. (See Photo No. 3, Appendix B.)

PHOTO. NO. 3
SPILLWAY TAKEN
FROM DAM LOOKING
NORTHEAST.

(3) If the concrete cap on the spillway is to remain the areas where spalling is occurring should be repaired.

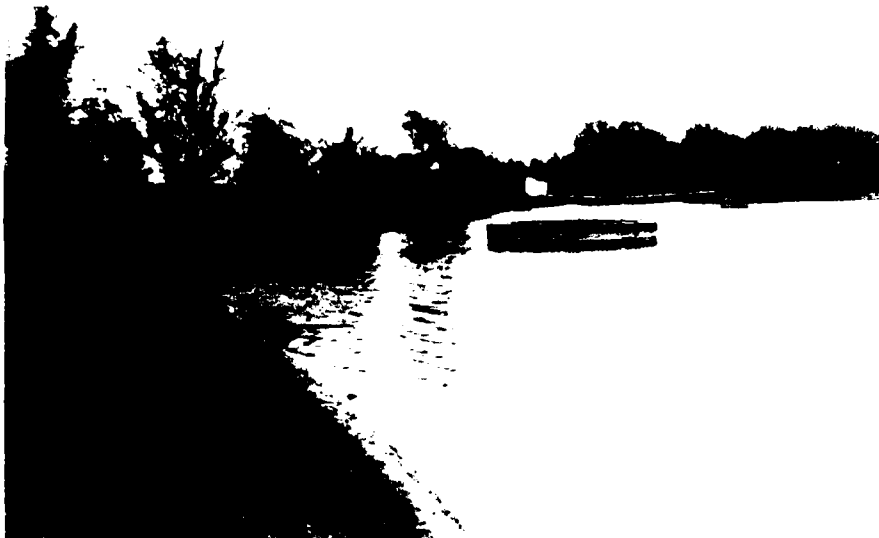
PHOTO. NO. 5
UPSTREAM SLOPE
TAKEN FROM
SOUTH LOOKING
NORTH.

(1) The trees (all relatively small) and/or brush on the upstream and downstream slopes should be removed and measures initiated to prevent their recurrence. If left uncontrolled, this vegetation could lead to potential of failure. (See paragraph 3.2.)

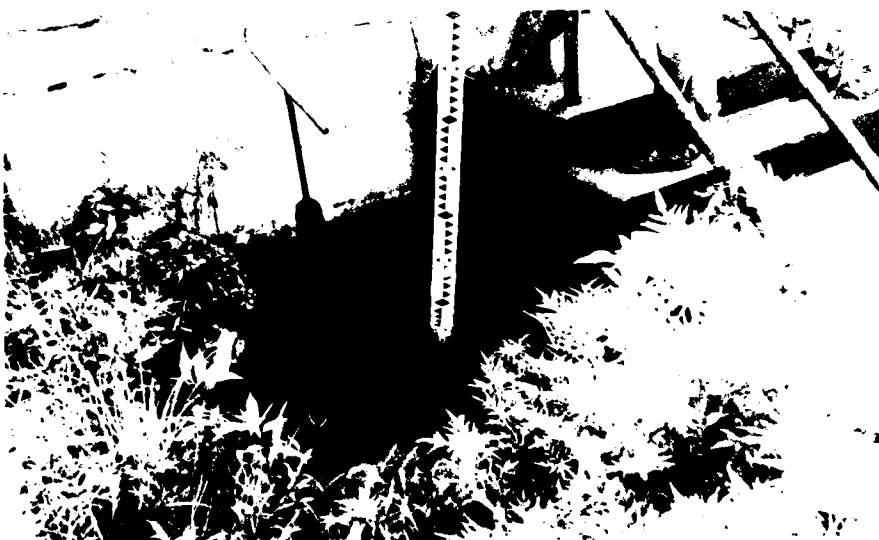
As discussed in paragraph 3.1a, above, a water supply line entering the pump house is broken and discharging water at the rate of about 2 gal/min.

The conditions observed that require immediate remedial action and additional investigations are the broken water line which is discharging very near the toe of the dam, and the apparent shear failure (slide) on the downstream slope. The possibility exists that the centerline crack (Sta. 4+00 \pm to 4+30 \pm), the embankment bulge (Sta. 4+00 \pm to Sta. 4+30 \pm) and the seepage (Sta. 3+00 \pm to Sta. 5+00 \pm) are related, and could indicate a serious embankment problem. This problem warrants an investigation in the near future by an engineer who is experienced and competent in soil mechanics and earth dam design. Vegetation on the upstream and downstream slopes could lead to potential of failure if left uncontrolled. The trees and brush growing on the embankment slopes should be removed. Continued spalling of the spillway cap could ultimately lead to deterioration of the top of the spillway. Seepage along the right side of the downstream toe does not appear to seriously affect the integrity of the dam.

PHOTO. NO. 6
POND AND BOIL
UNDER PUMPHOUSE
STEP. DOWNSTREAM
FROM C STA. 4+20±.

(2) The leak in the water supply line near the toe of the dam should be repaired in the near future. This leaky pipeline could lead to serious potential of failure of the dam. Regular inspections of the water supply system should be scheduled to assure the integrity of the system.

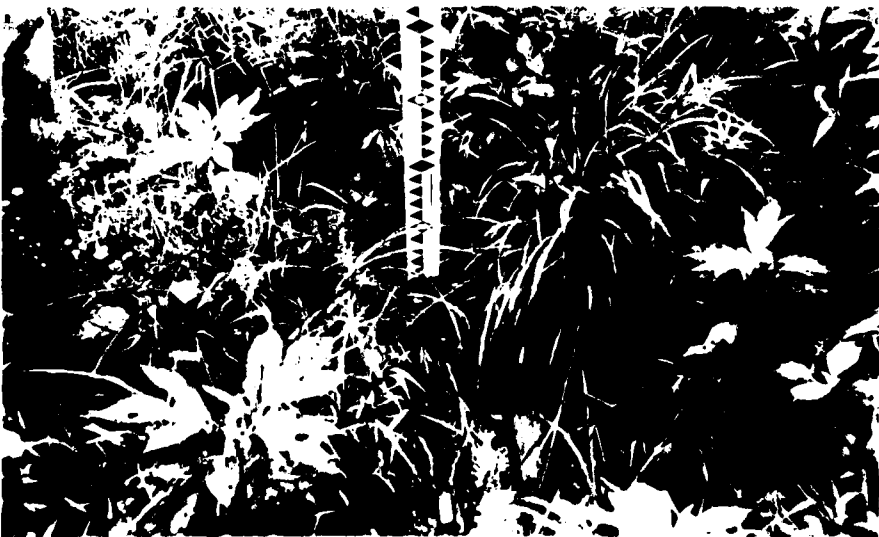
PHOTO. NO. 7
FLOW FROM BOIL
AT PUMPHOUSE.

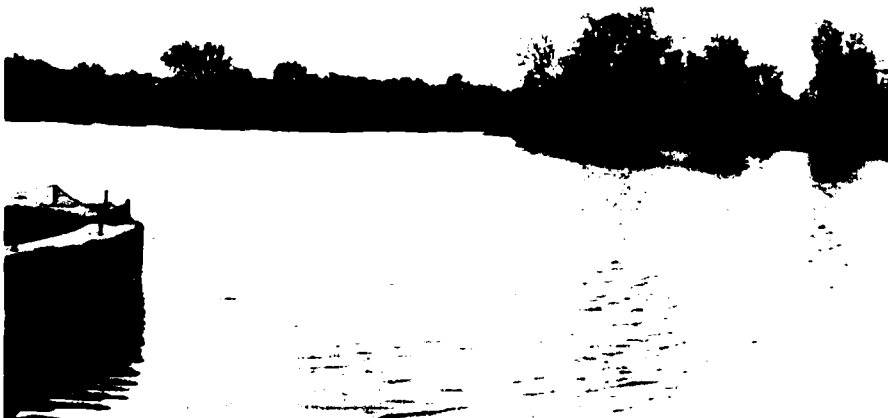
PHOTO. NO. 10
SHORE EROSION
ON EAST SIDE.

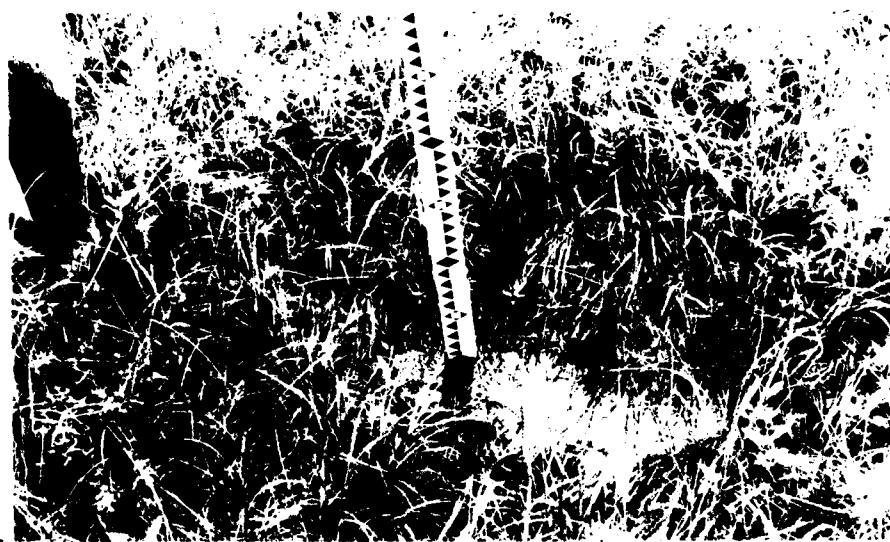
Seepage was existing along the north section of the downstream toe of the dam from about centerline stations 3+00 to 5+00 (see photo 12). The seepage discharge was clear and estimated at about 0.25 gal/min. No seepage was observed along the toe south of the pumphouse in the area where the concrete cutoff had been installed. A boil adjacent to the pumphouse was discharging an estimated 2 gal/min (see photo 6). The effluent was clear. It was reported by Mr. Roscoe that this boil results from a broken water line entering the pump station. There was no evidence of other boils or piping on the downstream slope or toe.

PHOTO. NO. 12
SEEP BELOW
CENTERLINE
STATION 4+50.

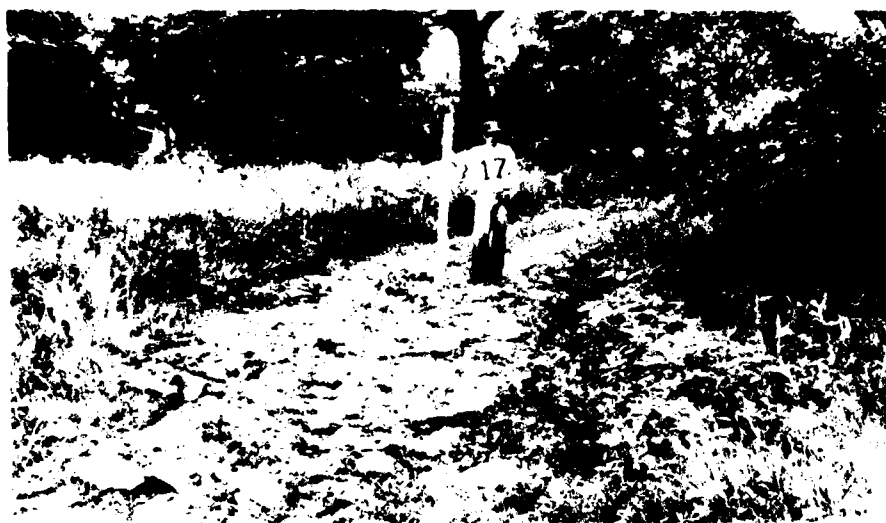
Fractured limestone bedrock was exposed in the north abutment above the crest elevation of the dam. The south abutment was mantled with CL soil.

PHOTO. NO. 15
LIMESTONE ON
NORTH ABUTMENT.
STA. 6+90⁺.

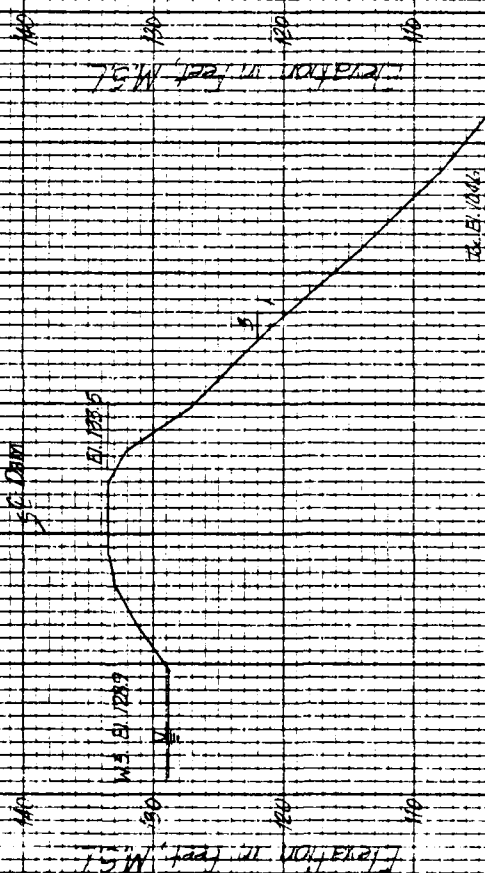
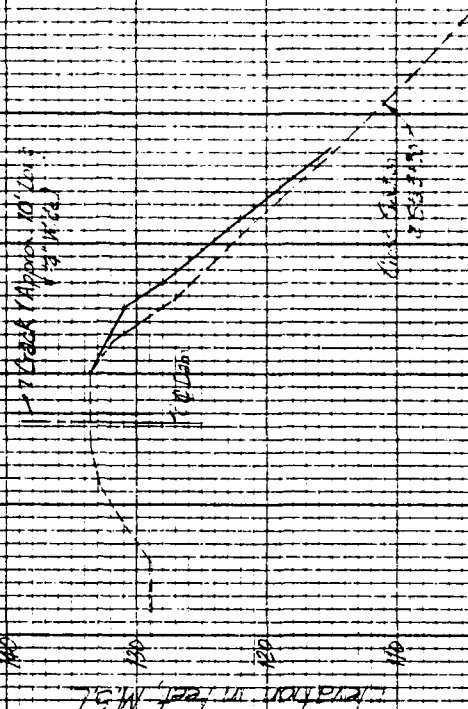
A small crack was observed parallel to and just downstream from the centerline of the dam in the area between \bar{Q} stations 4+00 and 4+30. The upper one-half of downstream slope is slightly bulged in this area (see measured sections shown in Appendix C).

Cross Section A at Sta 3+30

Cross Section B at Sta 4+50
